### DEFENCE SCIENCE REVIEW

## Experience gained by the Polish Military Contingent of IRAK in the field of logistic support and preparation of military equipment

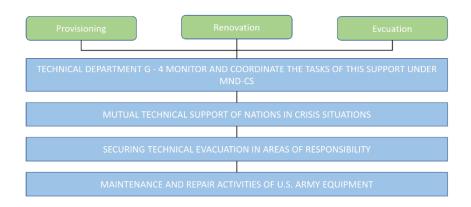
Fig. 2: Schematic of Multinational Division Central-South technical security system. Source: Own processing.

The Fig. 2 illustrates the tasks that were conducted in the field of operation of military equipment. In addition, operational processes were shown and the equipment responsible for technical protection was given.

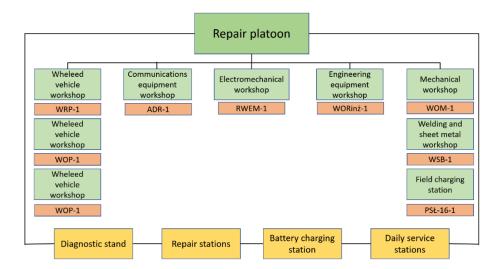
Looking deeper, the main element responsible for technical security was the repair platoon (Fig. 3.).

Fig. 3: Schematic of repair platoon.

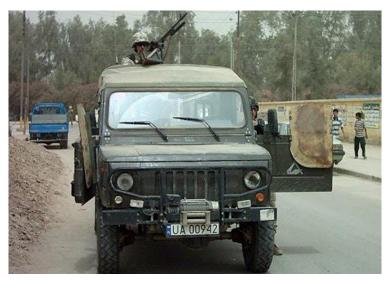
The biggest problems with operation in Iraq occurred with Polish Honkers. The Honker is a mid-range off-road vehicle of a passenger and cargo character, produced by the Polish company FSR in the years 1988 - 1997 as Tarpan Honker. Honker cars have been used in the Polish Army since 1990, while in 2009 their number in the army reached almost 2,500 (Wortak, 2015, p. 56-61). The Fig. 4. describes the honker from the first operations in Iraq.

Fig. 4: Honker original version

Honkers were used for patrolling and were the same as those bought in Poland. That is why the soldiers retrofitted the cars with metal sheets and armour plates. Out of concern for safety, the soldiers reinforced the sides of the cars with sandbags and bulletproof vests. At that time, design work on a latest version of the patrol car was underway in Poland. In the first operations in Iraq, the honker suffered from the following problems:

- weak armour;
- weak bumpers;
- unresistant door handles;
- no rod cutters;
- insufficient masking;
- poor resistance to IEDs;

- burning seats;
- inappropriate filters.

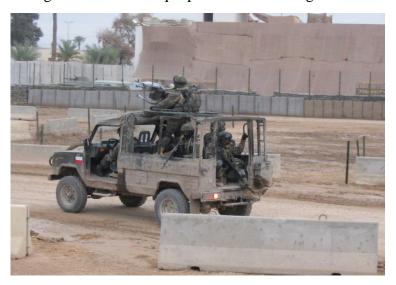
Therefore, it was necessary to adapt the honker to patrol tasks. A version adapted to the prevailing conditions in Iraq is presented in the Fig. 5.

Fig. 5: Honker customized version. Source: <a href="https://polska-zbrojna.pl">https://polska-zbrojna.pl</a> [access: 22.03.2023]

The adaptation of the car consisted, among other things, in installing a base for mounting a machine gun - 7.62 CP. Landing benches were made in the middle of the vehicle and the landing was reinforced with 5 mm sheet metal. There were also knives for steel rods developed by the opponent. Such rods were often deployed by the enemy to injure the crew of the vehicle. Knives made it possible to cut such a wire. In addition, due to heavy dust and a different natural environment, more frequent service periods began to be conducted. The frequency of changing the air and oil filters has been changed. In addition, the soldiers mounted tires on the bumpers for easier ramming of enemy obstacles. Other seats were also installed.

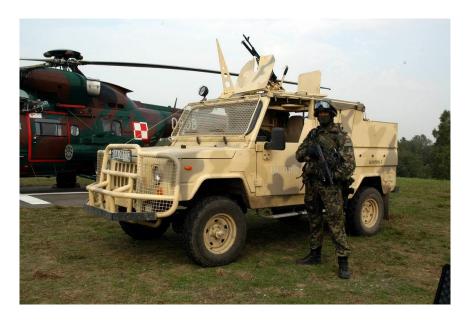
However, these changes were not enough. Soldiers often performed them on their own, out of concern for their safety. So, a thorough modernization of the honker to the SKORPION version was made. Changes included:

- installation of a rotating base for mounting a machine gun 7.62 PK;
- lining the floor of the passenger compartment with anti-splinter lining;
- changing the position of the rear seats;
- windshield mesh cover for protection;
- longer external steps along both sides of the vehicle;
- the possibility of partial or complete disassembly of the door;
- easily detachable canvas seat belts.

Figure 6: Modernization of the honker to the scorpion version Source: <a href="www.wikiwand.com/pl">www.wikiwand.com/pl</a> [access: 21.03.2023]

Several dozen pieces of the Skorpion model were produced. In 2007, the Polish Army used ninety units (Multrzyński, 2009, p. 45). However, the Skorpion had low stability due to the load and lack of side covers on the turntable and at the rear. The driver's head was not sufficiently protected by shields.

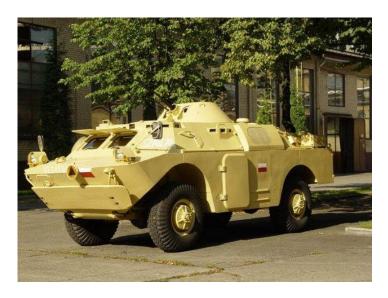
The modernized version of BRDM 2 is shown in the Fig. 7.

Figure 7: Modernization BRDM-2 Szakal Source: <a href="https://autokult.pl">https://autokult.pl</a> [access: 26.03.2023]

In Iraq, Polish soldiers used BRDM 2 vehicles. The vehicle was developed in the Design Office of Factory GAZ in 1962. Its serial production was launched in 1963. It was used in over forty-five countries and many military missions. Due to problems like those related to Honker and Star, the car was modernized to the BRDM 2 Szakal version. It is worth adding that it was the Polish Military Contingent in Iraq that contributed to the introduction of modernization. Modernization included:

- replacement of the 14.5 mm KPWT rifle with the 12.7 mm NSW rifle,
- the use of a passive day-night sight,
- introduction of passive observation devices for the commander and driver,
- installation of air conditioning in the combat compartment,
- the use of an engine cooling system with increased efficiency,
- application of the FONET internal communication system,
- equipped with a RRC 9500 digital radio station and two portable radio stations,
- painting in desert camouflage.
